# "Imminent closure of local hospital due to poor water quality"

# The water issues

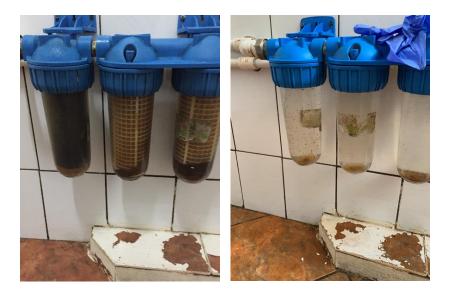
The hospital requested help over many years but only received local replaceable small micro filters and active carbon filters from Contractors against any tenders they raised in the past

Although effective for small flow rates into the kitchen for short periods of time this was not the solution for the whole site and still required boiling before use. These filters although relatively inexpensive still require regular monitoring and replacement requiring the kitchen supply to be momentarily shutoff to replace.

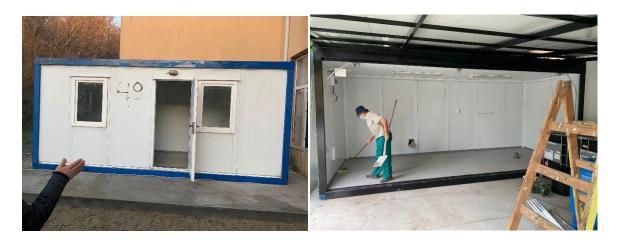
During the early Summer an outbuilding infrastructure was built with a concrete hard standing and a 20-foot ISO container framed portacabin erected.

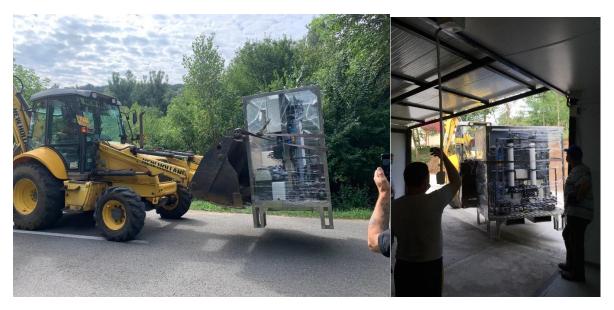
The whole Oasis system in its component parts was quickly brought up to the site using a JCB up the rural approach road and placed into the new portacabin area.

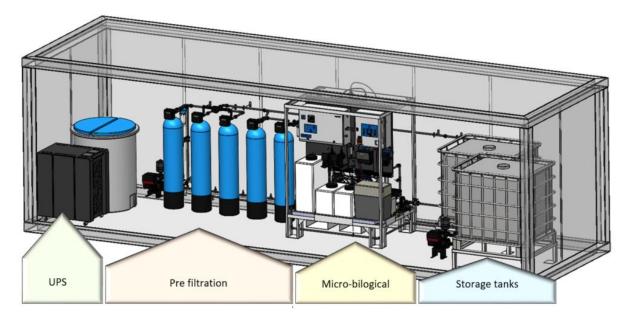
The whole Oasis system solution comprises of 4 main components

- 1. The prefiltration used to remove the physio-chemical contamination
- 2. The ultrafiltration system that removes the microbiological and controls the whole solution
- 3. Storage and transfer tanks
- 4. Uninterruptible power supply (UPS) used to clean up the power supply and provide battery power to continue to run the entire solution should there be a power outage and fill the time needed to start the emergency generators situated within the hospital grounds.

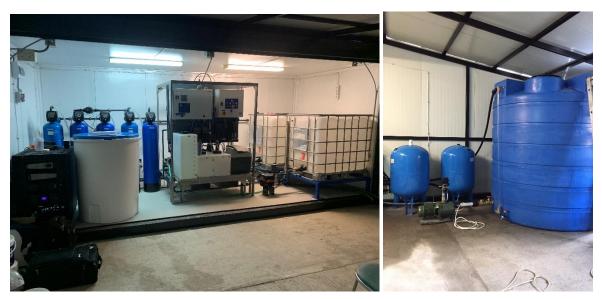
Within 2 days of plumbing and adjustment the entire solution was assembled, interconnected and producing drinking water to EU98/83 standards at a flow rate of 1000 litres per hour. The water was transferred into the hospitals 5000 litre storage tank which then is sent into the hospital infrastructure via a pumping solution.

This solution allows for a continuous delivery of water on demand throughout the day and night without the need to turn of the supply to replace filters. Every part of the hospital can receive the same quality water from a single water purification solution.

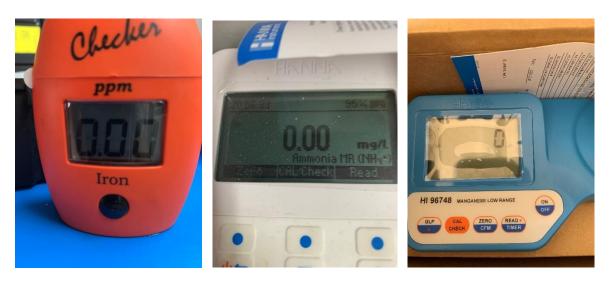
Multiple additional physio-chemical tests were repeated over the remainder of the working week to ensure that the key contaminates were consistently under the legal limits according to the EU water regulations and checking the raw water contamination to ensure that this was not simply due to the water supply contamination dropping by itself.
